Susquehanna River Basin, Inventory  
Number NY-575. Nanticoke Creek Watershed  
Project Site 9E. Broome County, New York.  
Phase I Inspection Report.

PHASE 1 INSPECTION REPORT  
NATIONAL DAM SAFETY PROGRAM  
NANTICOKE CREEK WATERSHED PROTECTION PROJECT  
DAM SITE No. 9E  
I.D. No. NY 575  
(#85D-3646)  
SUSQUEHANNA RIVER BASIN  
BROOME COUNTY, NEW YORK

Name of Dam:	Nanticoke Creek Watershed Protection Project Dam Site No. 9E I.D. No. NY 575 (#85D-3646)
State Located:	New York
County Located:	Broome
Watershed:	Susquehanna River Basin
Stream:	Unnamed tributary of Nanticoke Creek
Date of Inspection:	November 8, 1978

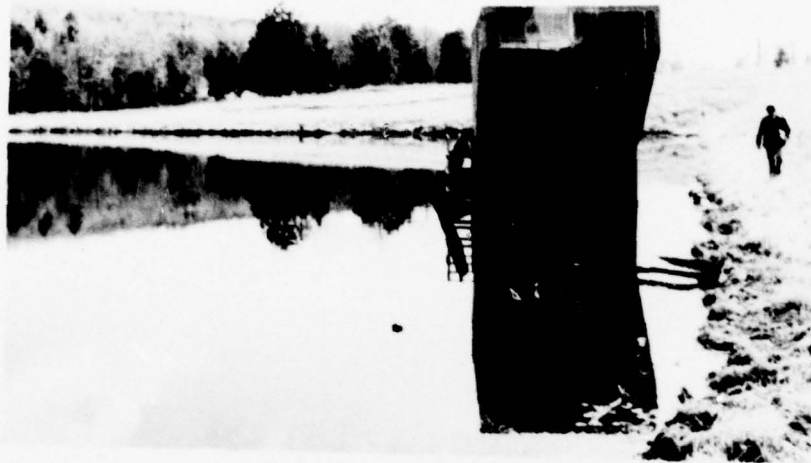
RISER - PRINCIPAL SPILLWAY INLET

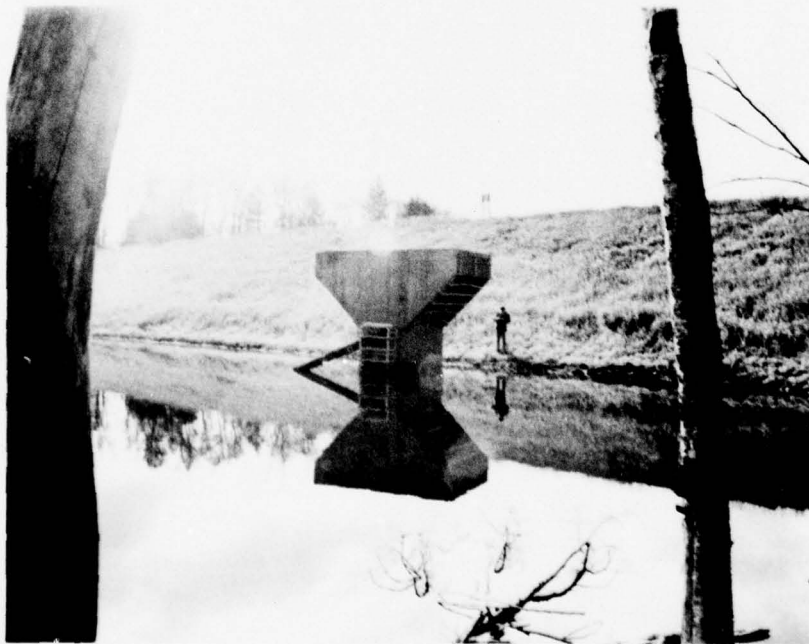
RISER - NOTE LOG LODGED IN TRASH RACK

b. Principle Spillway 26.2' HIGH RECTANGULAR RC DROP INLET;  
36" DIA RC PRESSURE PIPE ; CONCRETE IMPACT  
BASIN - A 10" DIA. LOG WAS LODGED IN THE RISER'S TRASH RACK.  
ALL IN SATISFACTORY CONDITION - VERY SLIGHT SEPARATION  
AROUND RC PIPE AT JUNCTION WITH IMPACT BASIN  
HEADWALL -

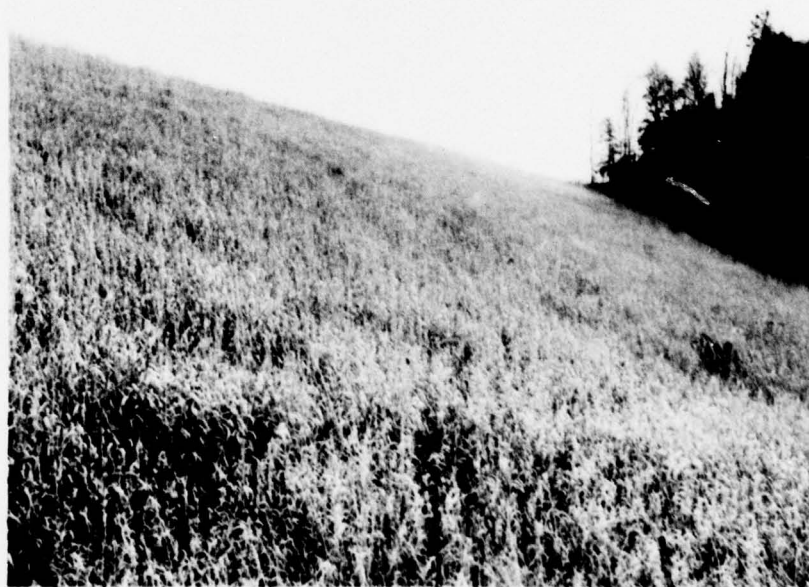
The earth embankment showed no signs of distress. The vertical and horizontal alignment of the crest of both embankments appeared to be satisfactory, with no visible surface cracks appearing on the crest or embankment slopes. There were no areas of serious sloughing or subsidence noted. Some minor sloughing was observed on the upstream slope in the range of fluctuation of the water surface level.

No undesirable vegetative growth of animal penetrations into the slopes were observed. However, on the date of the inspection, the grass on the embankments had not been mowed.

DOWNSTREAM SLOPE OF NORTHERN EMBANKMENT

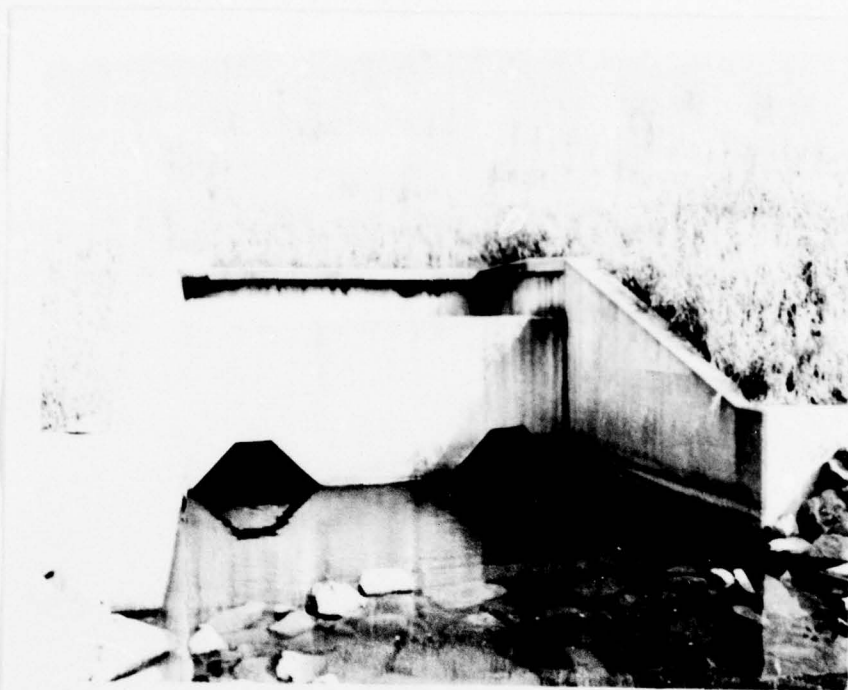
IMPACT BASIN - LOOKING UPSTREAM

h. Joints - Construction, etc. SOME MORTAR WAS MISSING  
AT IMPACT BASIN - CONDUIT GASKET

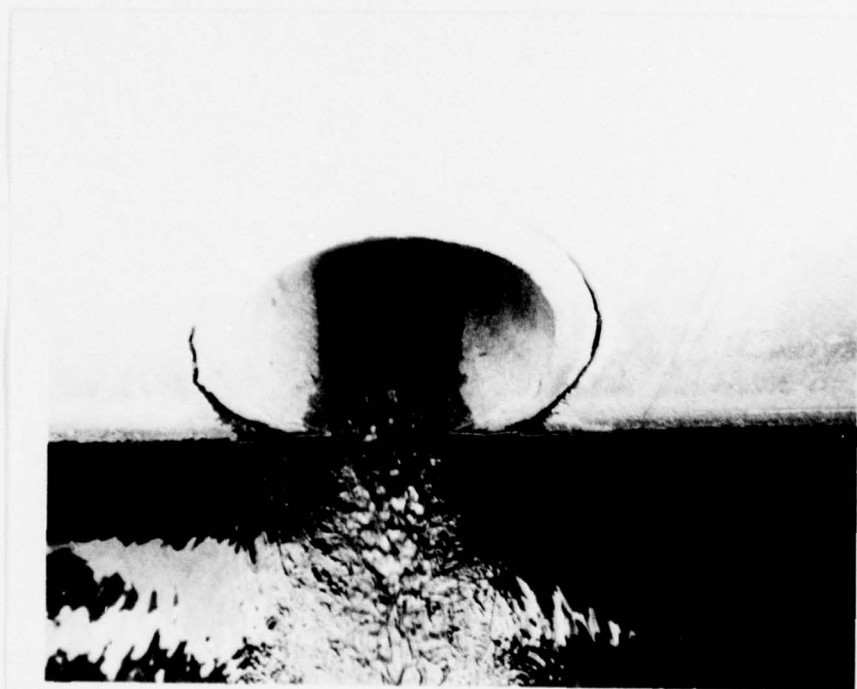
The principal spillway consists of the vertical drop inlet structure, a reinforced concrete pressure pipe through the embankment, an impact basin and an outlet channel. All of these components were in satisfactory condition. There was a small gap around the principal spillway pipe at its joint with the headwall of the impact basin.

OUTLET TO PRINCIPAL SPILLWAY PIPE
